TSB No.	KFE10-21-V070-ED	TSB Type	Field Fix	Language	English
Distributor	C41VD(LOCAL)	Published	5/28/2010	Modified	
Model	Cee'd [ED]-(2007MY)				
Area & Distributor	East Europe & Falcon Auto				
Gr./Sys./Comp	Система подвески / Система передней подвески / Передний стержень стабилизатора				
Subject	(REVISED) FRONT STABILIZER LINK ASSEMBLY INSPECTION AND REPLACEMENT				
Description

**REVISION NOTICE****THIS BULLETIN SUPERSEDES PREVIOUS TSB KGE09-21-V160-ED. DISCARD THE PREVIOUS TSB.**

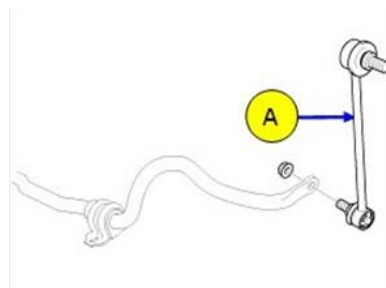
- Symptom/Condition  
On some cee'd (ED) vehicles, when driving on a bumpy or uneven road, a knocking noise might emanate from the front suspension.
- Cause  
Front stabilizer link assembly ball joint contamination.
- Countermeasure  
Replace the front stabilizer link assembly according the procedure below.

*While replacing the front stabilizer link assembly unit (A,) be sure to use correct tightening torque for the nut while assembly.*

- Tightening torque Nm (kgf.m, lb-ft):  
100~120 (10.0 ~12.0, 72~87)
